**Detection of shear zones in a natural clay slope  
using the CPT and continuous dynamic sampling**

Submitted to the  
Canadian Geotechnical Journal

July 15, 1998

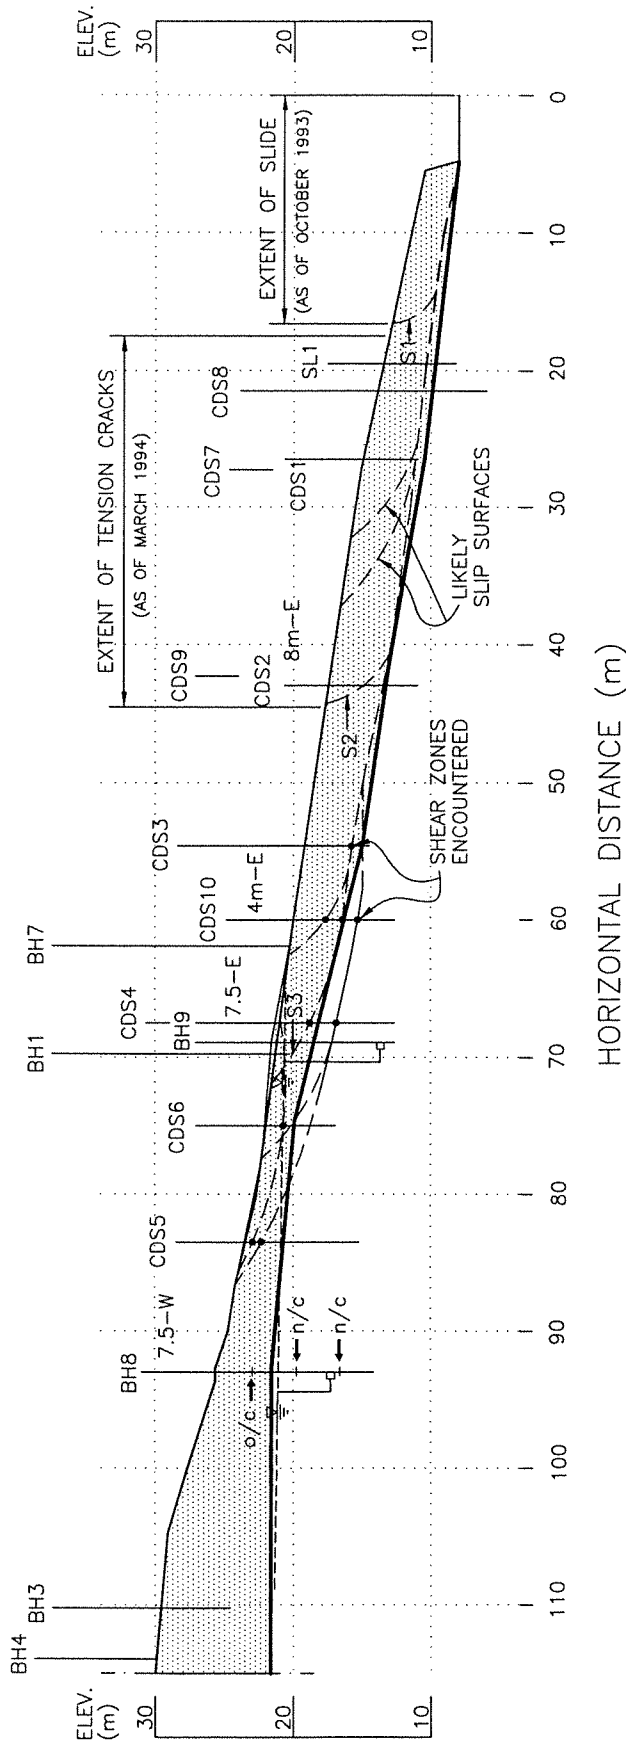
**FIGURE 3 - CROSS SECTION A-A  
(SHOWING CONTINUOUS SAMPLING PROFILES)**

was evident in the upslope areas, the presence of shear surfaces in the continuous samples collected in these areas in December 1995, and described later under “Continuous dynamic sampling (CDS)”, confirms that ground movements had likely occurred at some time in the past (see, e.g. profiles at CDS5 and CDS6, Figure 3).

The pre-existing shear surfaces observed from examining continuous samples obtained at CDS1 to CDS10 are summarized in Table 2 and illustrated in Figure 3. As can be seen, shear zones were encountered within the top 1 to 3.5 m of the weathered clay crust, as well as within the top 3 m of the unweathered layer. Water contents of the shear zones within the weathered layer ranged from about 40% to 80%, with values of between 40% to 50% corresponding to the shear zones within the unweathered stratum.

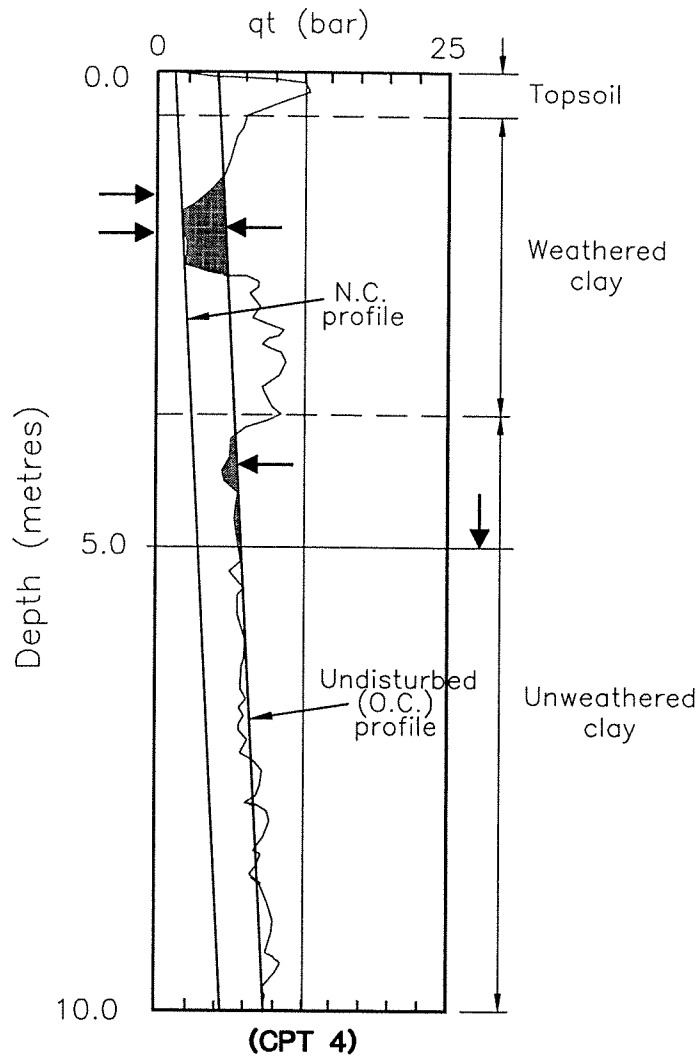
**FIGURE 4 - IDENTIFICATION OF SOFTENED ZONES FROM CPT PROFILES AND COMPARISON WITH CDS IDENTIFIED SHEAR SURFACES**

The CPT  $q_t$  profile in Figure 4 indicates some surface fill overlying a clay deposit which appears to be over-consolidated in the upper few metres, becoming less over-consolidated with depth. The CPT profile also indicates that the clay deposit is quite variable with rapid changes in penetration resistance. The measured values of  $q_t$  obtained from the seven CPTs vary between about 2 bar and about 25 bar, with the highest values recorded in the desiccated clay near the ground surface, see Figure 5. The low capacity CPT equipment had an accuracy in  $q_t$  of  $\pm 0.25$  bar (1 bar = 100 kPa).

To establish the range of  $q_t$  for undisturbed clay, CPT5 was carried out (adjacent to CDS5) in an area with no apparent previous surficial (slope) movement and where  $q_t$  varied between about 5 bar close to the surface and 9 bar at a depth of 10 m. This undisturbed clay profile is superimposed on Figure 4 and labelled “Undisturbed (O.C.) profile”.  $q_t$  profiles of this magnitude suggest some degree of over-consolidation and  $q_t$  values less than this reference line are indicative of some softening and loss of undrained shear strength, although not necessarily slip surfaces or previous ground movement, see shaded area labelled “Zone of softened clay” on Figure 4.

Furthermore, the shear surfaces observed at the adjacent CDS test hole are also incorporated in Figure 4. Of particular note is the agreement between depths at which significantly lower  $q_t$  values - labelled as “Softened zones” - were measured with the CPT and approximate depths where shear surfaces were identified by continuous sampling.

It has been illustrated in the preceding sections (Figure 4) that there is a good correlation between CDS detected shear surfaces and softened zones identified from low  $q_t$  values in CPT profiles. Table 3 presents a comparison of CPT identified softened zones and CDS detected shear surfaces at the seven test locations where both continuous sampling and cone penetration testing were carried out. As can be seen, there is generally good correlation between the depths over which softened zones were identified and depths at which shear surfaces were detected. It should be remembered that the CDS testholes were located within 1-2 m of each of the adjacent CPT testholes. Furthermore, as outlined in the

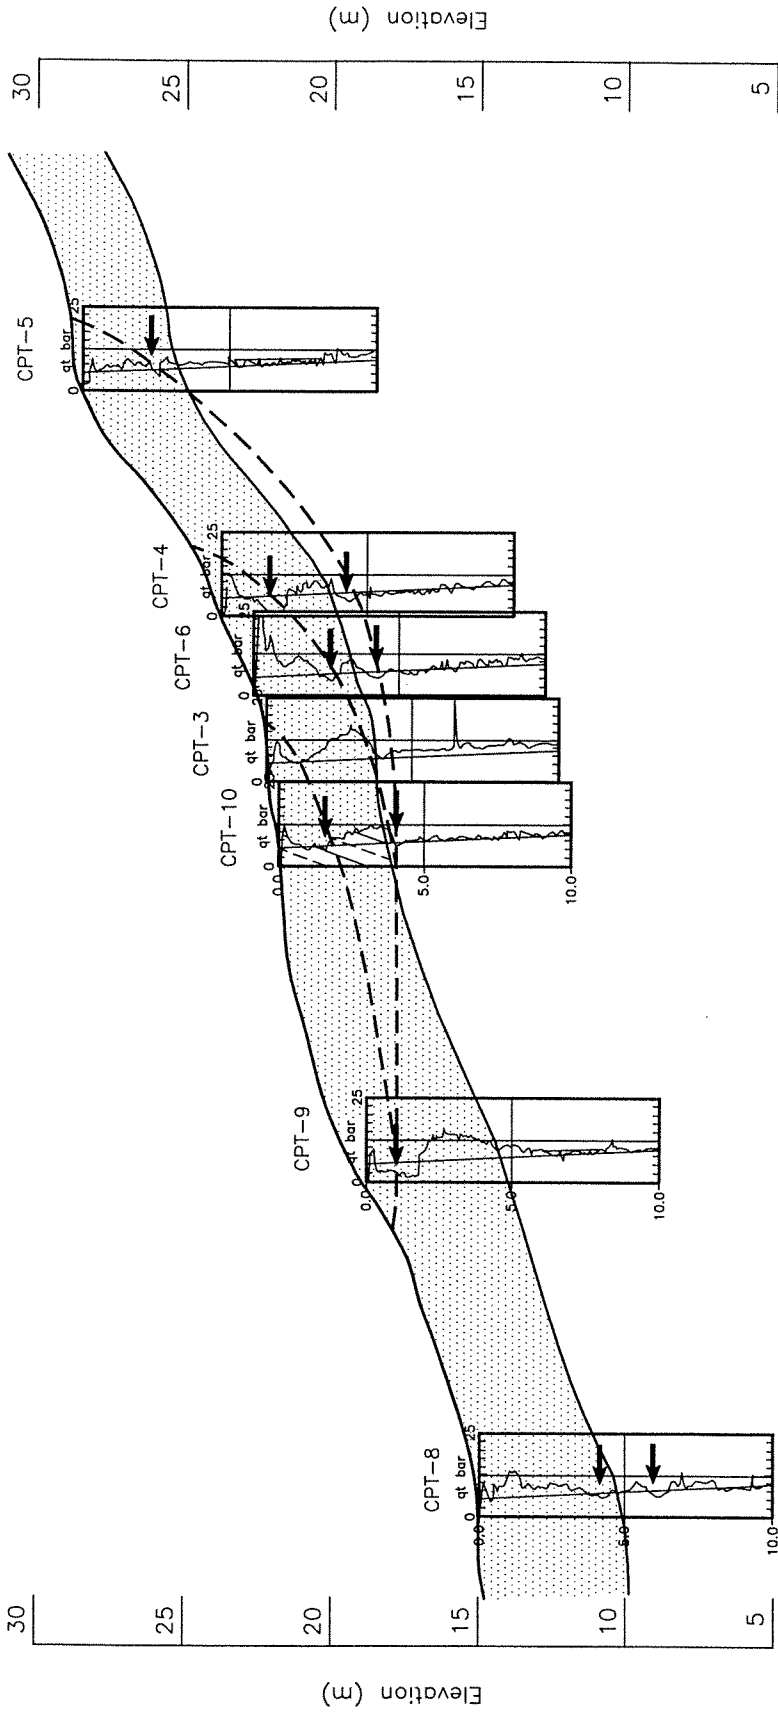
**FIGURE 5 - CROSS SECTION B-B (SHOWING CPT PROFILES)**

Figure 5 presents the CPT  $q_t$  profiles along section B-B (Figure 1), together with the softened zones identified. Also shown on Figure 5 are three likely slip surfaces passing through the CPT identified softened zones.

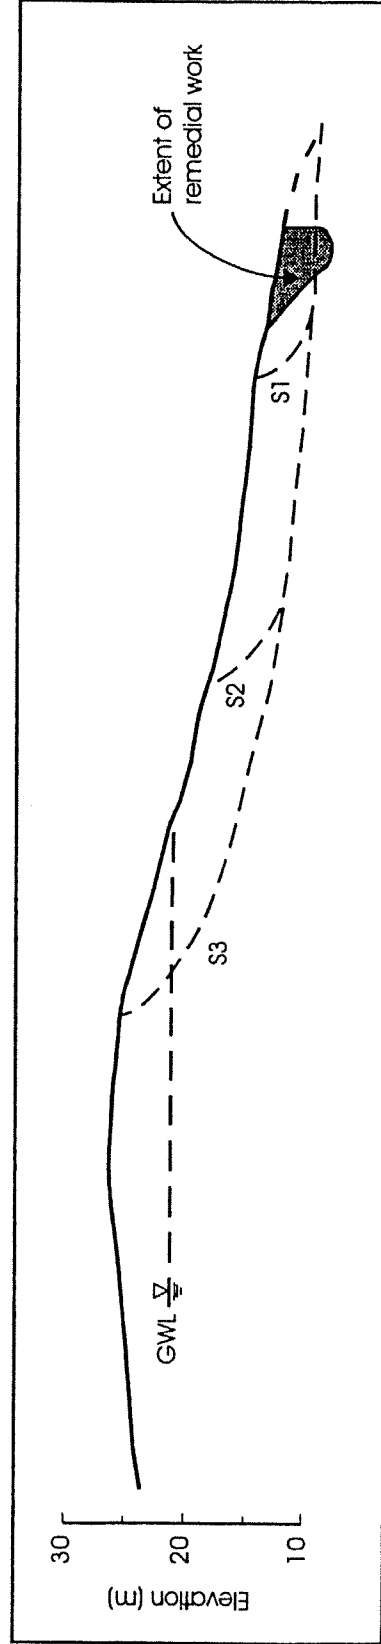
FIGURE A1 - RESULTS OF STABILITY ANALYSES ALONG SECTION C-C

In the summer of 1993 a 1.5 to 2 m high cut was made at the toe of the slope to accommodate an access lane. Back-analysis shows that the factor of safety corresponding to a likely slip surface S1 (Figure A1) is near unity, thus indicating that the slope was only marginally stable prior to commencement of excavation works for the access lane. As can be seen from Figure A1, these excavation works resulted in reducing the factor of safety which consequently led to a slide occurring in the general area of this cut slope between October 25 and 26, 1993. This toe slide resulted in the instability of the upslope areas, with the factor of safety corresponding to an upgradient slip surface S2 (Figure A1) - initiated approximately 25 m upslope from the toe - reducing from 1.26 to 0.92. By January 1994 a tension crack was noted at the location of slip surface S2. Subsequent to the development of this tension crack, a slope indicator (SL1, Figure 1) was installed along the south property boundary in February 1994 and indicated a shear zone between 3 to 4 m below ground level.

Analysis shows that slip surface S3 extends beyond the tension cracks observed in January and February 1994 and corresponds to a computed factor of safety of 0.91, thus suggesting that ground movements could have extended further upslope. Although no tension crack

Year	Stage	Soil Parameter	F.O.S. along slip surface		
			S1	S2	S3
Summer 1993	Before excavation at slope toe	$\phi'_{cv}$ throughout slope	0.98	1.26	1.22
Fall 1993	Immediately after excavation at slope toe	$\phi'_i$ along S1, elsewhere $\phi'_{cv}$	0.68	0.92	-
January 1994	After development of tension cracks in upslope areas as far as S2	$\phi'_i$ along S1 and S2; elsewhere $\phi'_{cv}$	-	-	0.91
March 1994	After completion of slope stabilization works (extent of which is shown)	$\phi'_i$ throughout slope, $\phi'$ of $40^\circ$ at toe berm	-	1.23	0.77
