**Detection of shear zones in a natural clay slope  
using the CPT and continuous dynamic sampling**

Submitted to the  
Canadian Geotechnical Journal

July 15, 1998

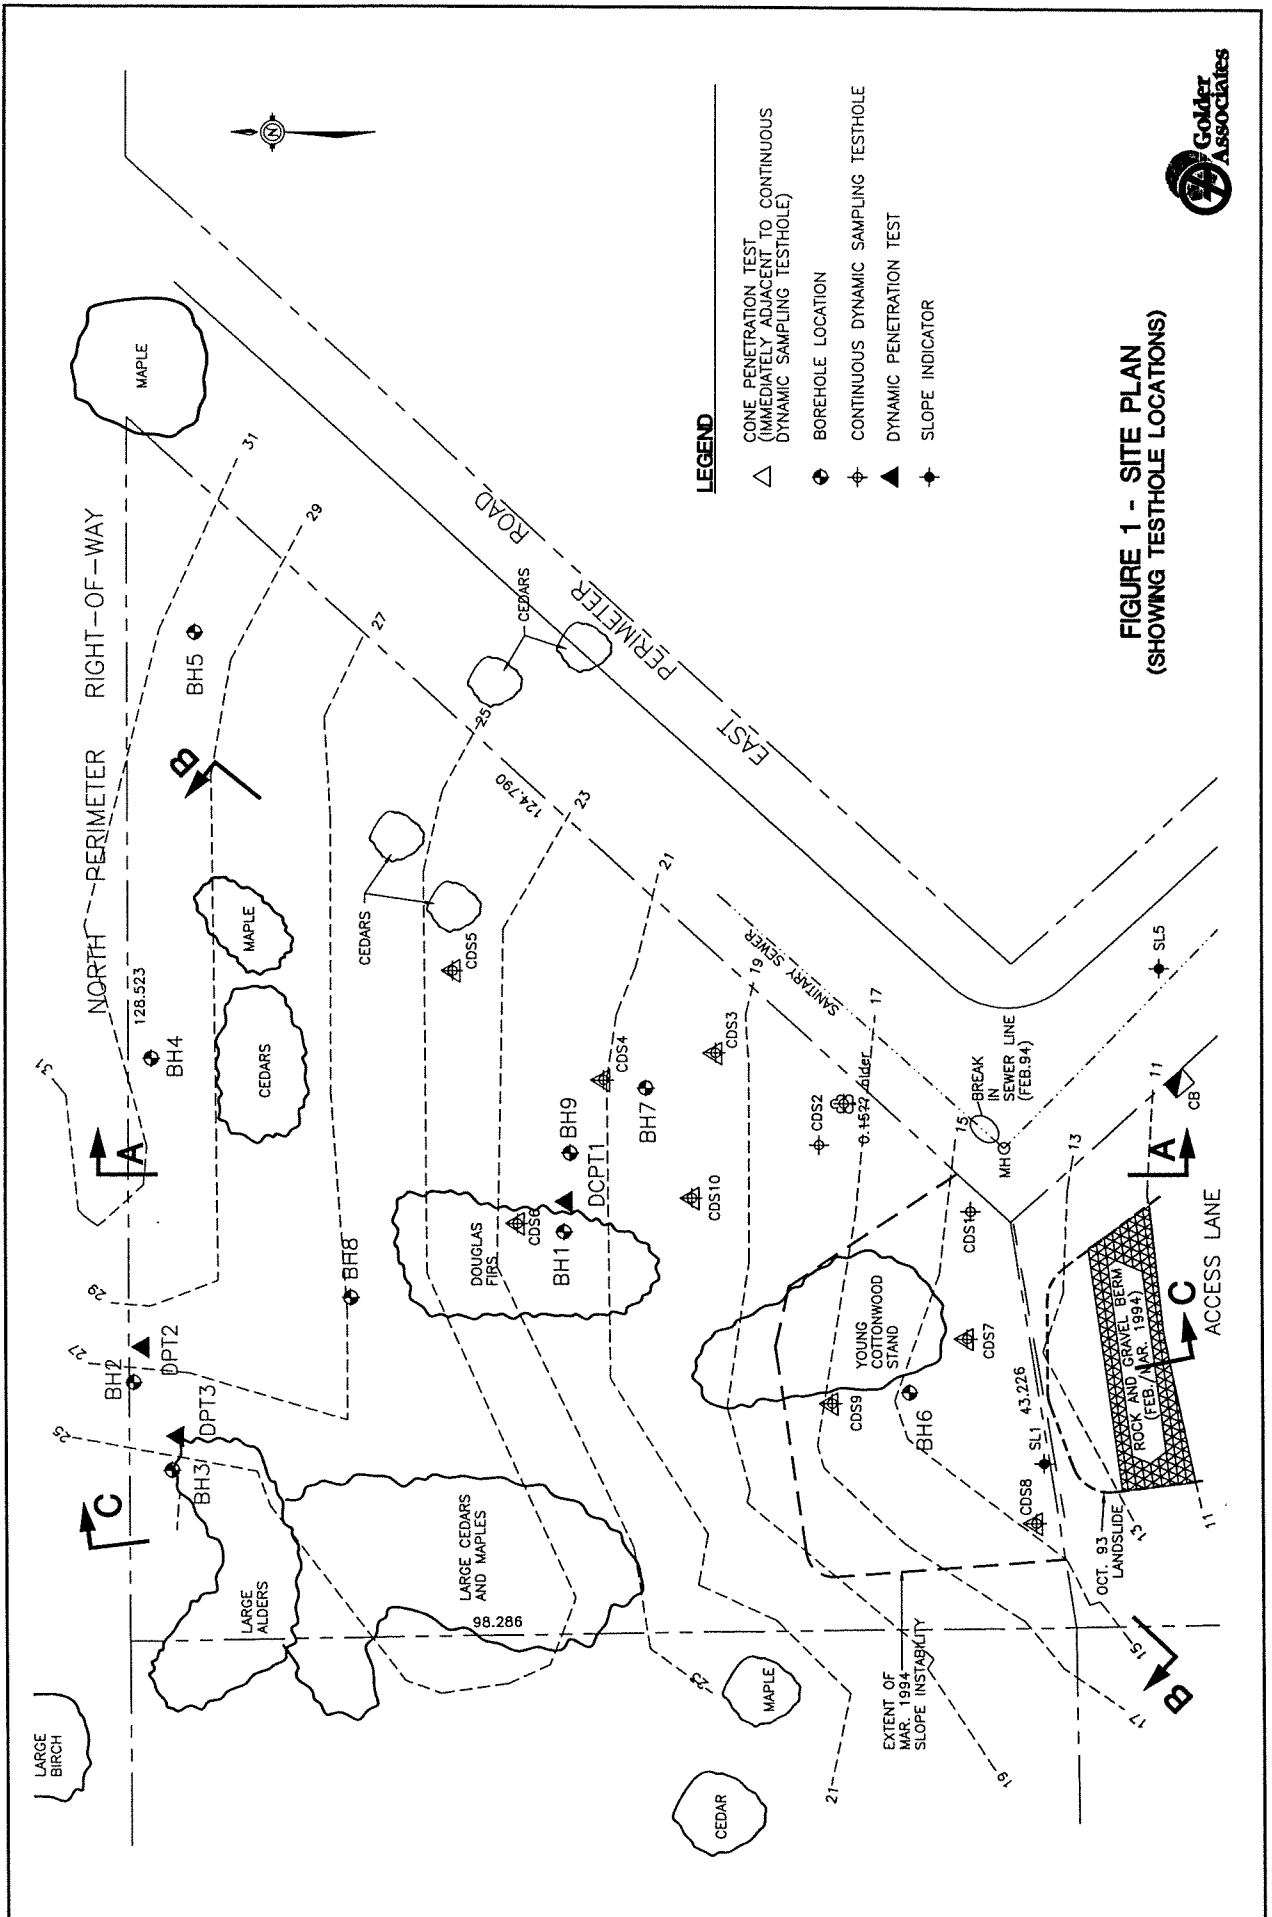
**FIGURE 1 - SITE PLAN (SHOWING TESTHOLE LOCATIONS)**

Slope remedial works commenced on February 25, 1994. However, following heavy rainfall between February 26 and 27, 1994, additional slope movement occurred and by March 4, 1994, approximately 30 tension cracks had developed upgradient from the slope toe, the aerial extent and depth of which are shown in Figures 1 and 3 respectively. By March 9, 1994 measured lateral movements had reached greater than 1.2 m within the slide area. Slope stabilizing piles were subsequently installed during the summer of 1994, and resulted in arresting further movement of the slide area by the autumn of 1994. The factor of safety following slope stabilization works is computed to have increased to 1.23, Figure A1. This increase in factor of safety is confirmed by the survey data collected between July 1994 and April 1995, which indicate between 5 to 10 mm of downslope movement over a period of nine months following completion of remediation works.

Cone penetration testing (CPT) was carried out at seven locations, within 1-2 m of adjacent continuous sampling test holes CDS3 to CDS6, and CDS8 to CDS10, respectively (see Figure 1). The CPT device comprised a standard 10 cm<sup>2</sup> penetrometer with a low capacity 2.5 tonne tip load cell. Except for CPT8 which was advanced to 20 m below the surface,

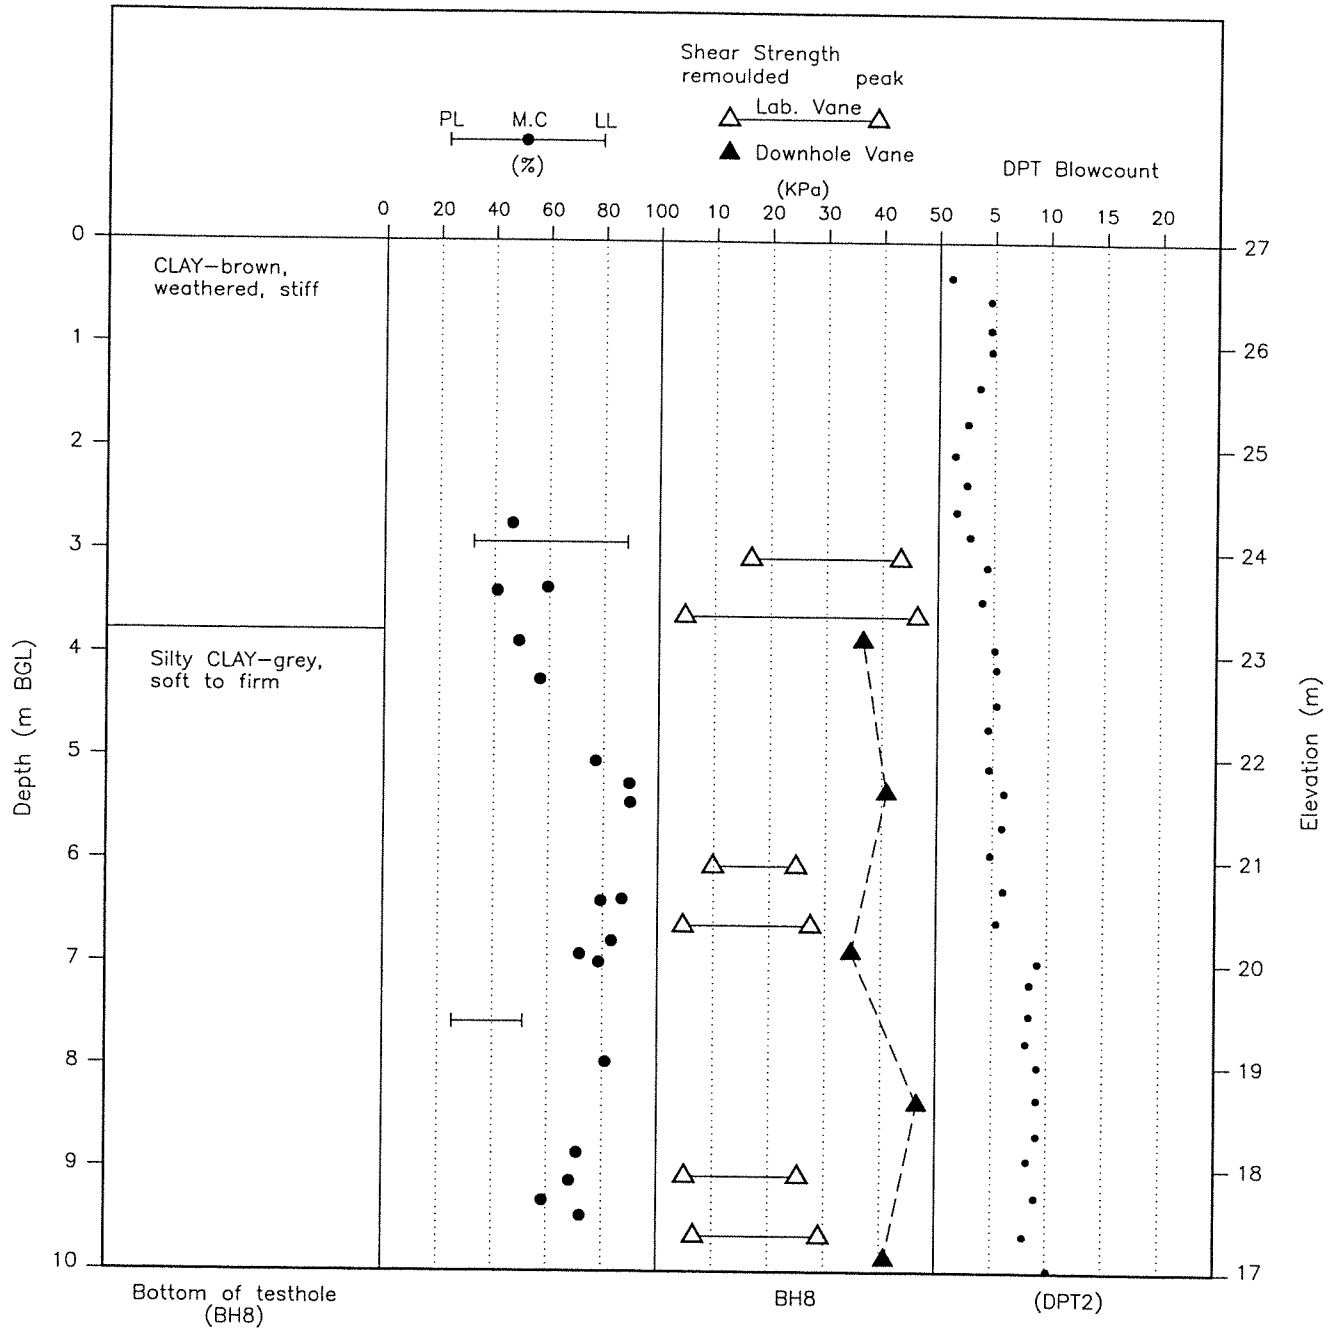
**FIGURE 2 - TYPICAL BOREHOLE LOG TOGETHER WITH PROFILES FOR ATTERBERG LIMITS, WATER CONTENT DETERMINATIONS, FIELD AND LABORATORY VANE STRENGTHS, AND DPT BLOWCOUNTS**

(CPT3 to CPT6, and CPT8 to CPT10). Dynamic penetration tests (DPT) were carried out adjacent to boreholes BH1 to BH3, with in-situ downhole vane shear tests (VST) made at borehole BH8. The DPT corresponded to the International Reference Test Procedures for Dynamic Probing Super Heavy (DPSH) and comprised driving a 60° solid cone shaped probe (60 mm diameter; 150 mm sleeve) using a 140 lb (63.5 kg) Pilcon trip hammer which utilizes a winch and falls freely a height of 30" (0.76 m), thus simulating closely the Standard Penetration Test (SPT) procedures. The two techniques of continuous dynamic sampling (CDS) and CPT were further utilized for delineating the aerial extent and depth of instability of shear zones within the natural clay soils underlying the site. The locations of these test holes are shown in plan in Figure 1, while Figure 2 presents a typical borehole log together with profiles for Atterberg limits, water content determinations, field and laboratory vane strengths, and DPT blowcounts.
